Inspection Summary **NOTE: Client must also review entire report and not rely solely on the summary notes.**

INSPECTION ADDRESS: West Chester, PA 19382

Confidential Inspection Report

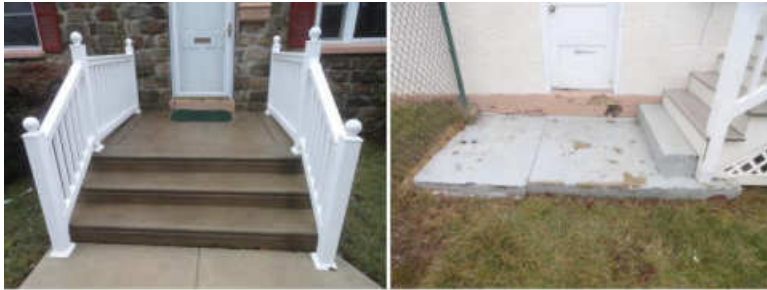
Stoops/Stairs Front Stoop appears adequate at this time. **The stoop at the back of the home has settlement from water damage.**

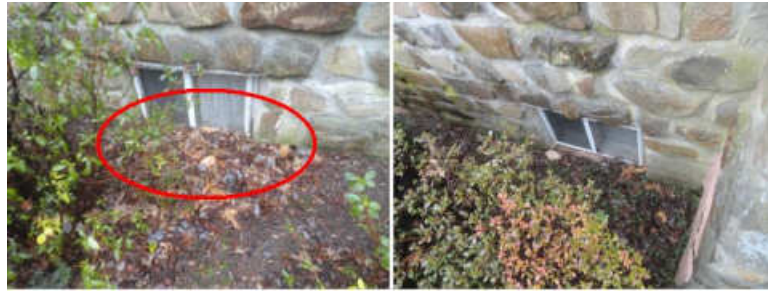
Susceptible to water infiltration. Recommend, Well(s)/Cover(s)

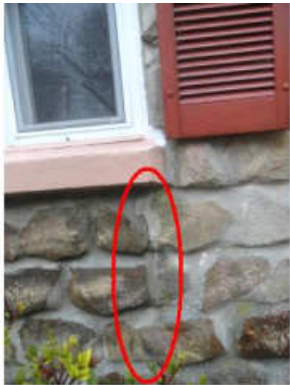
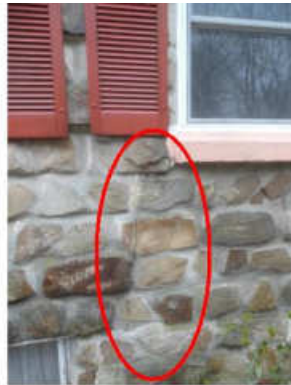
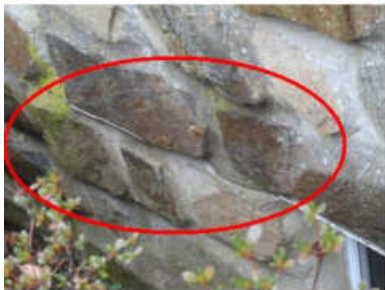
Cracked section(s) should be further investigated prior to settlement. Under windows.

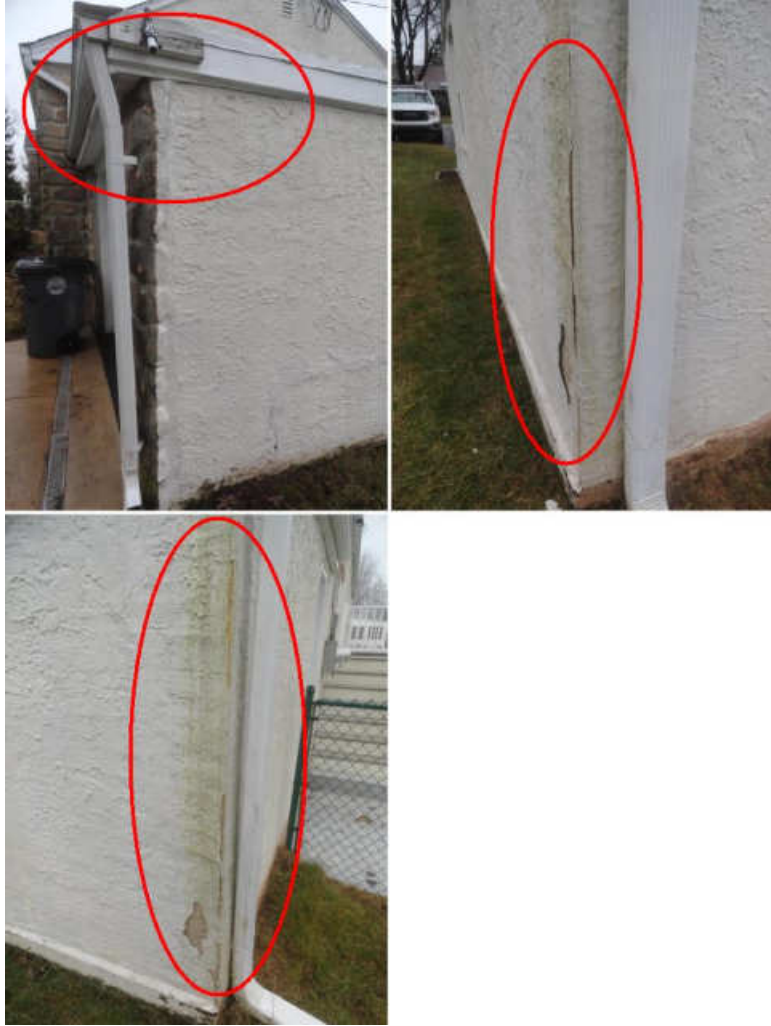
Separating, this is usually caused by water infiltration/ moisture getting behind the material. This should be further investigated and repaired prior to settlement by a professional stucco expert. There was cracking that was caulked on left side and back. The separating is happening on the garage. It is starting along the top of the wall where the roof rest on.

Previous repairs were done on cracks. **Bulge above window of garage.**

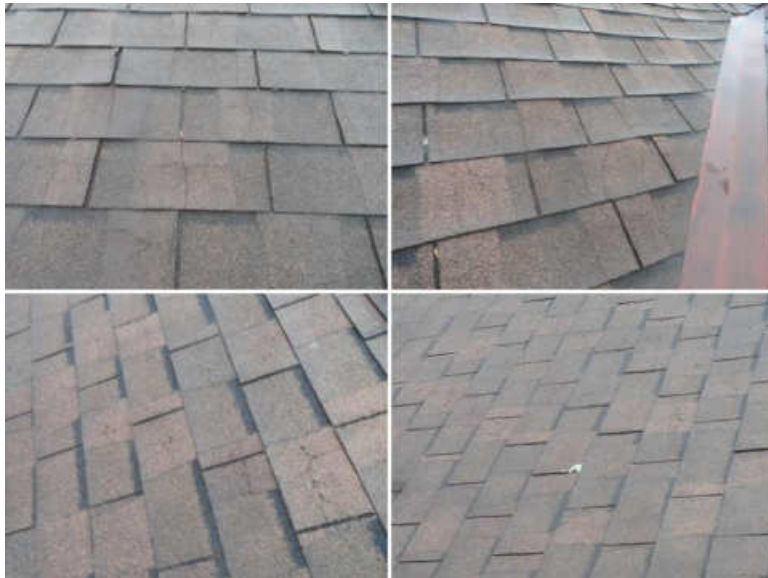
At or nearing the end of life. Roof is 15 plus years old. Cracking, heavy worn area such as holes in shingles. Recommend a professional roofer to further evaluate and repair.

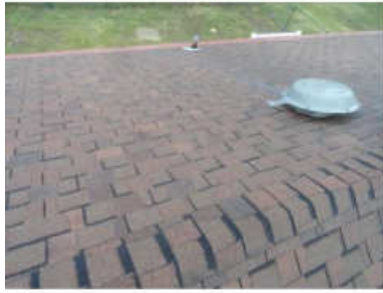
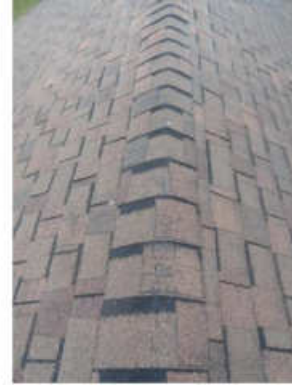
Nearing the end of life.

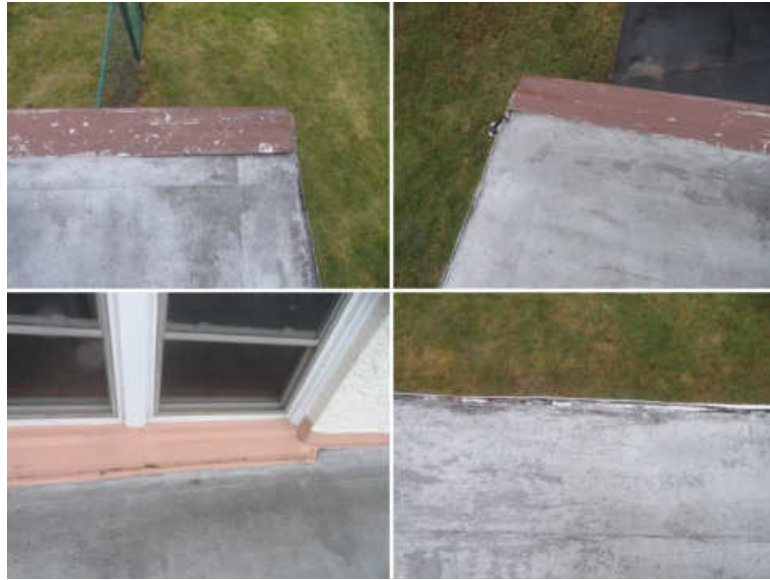
Alligatoring, Flashing along the edges needs repairs, this is causing water infiltration behind stucco. Flashing on gutters was not installed properly, screws

are used through the roofing material but was not sealed properly.

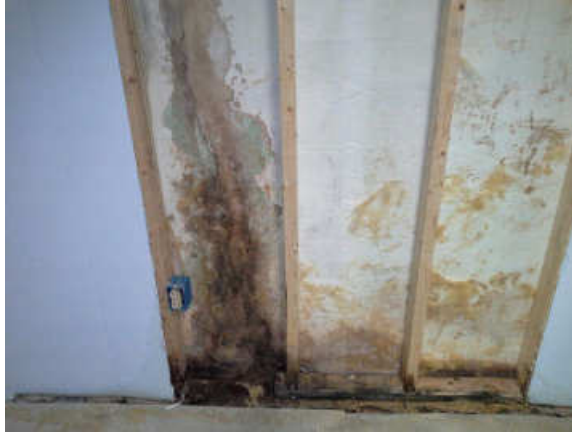
Observation, Vertical. Recommend a professional contractor for repairs.

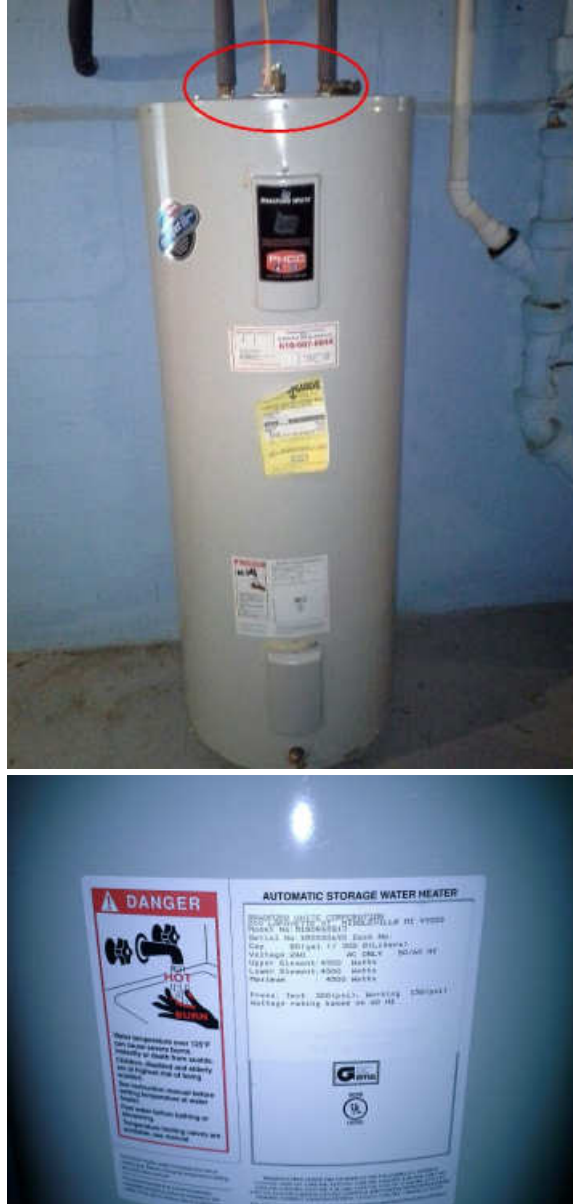
TPR not extended to within 6-8 inches of floor.

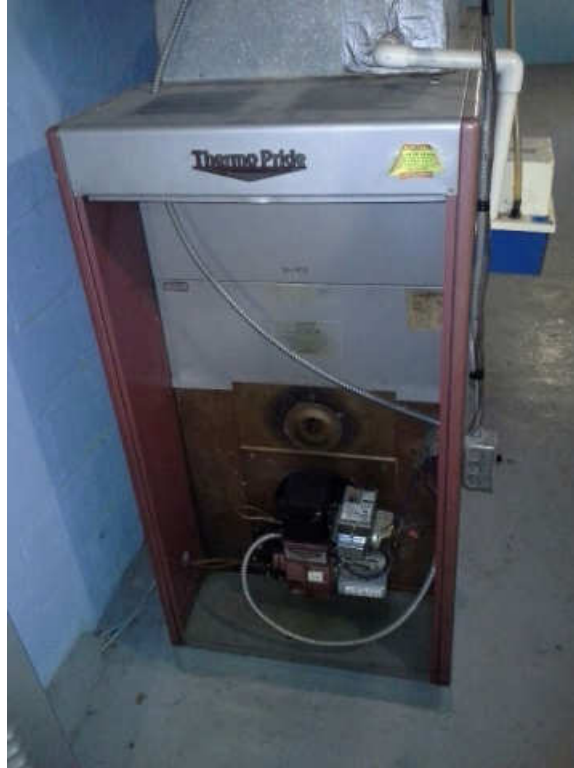
No recent signs of service or cleaning, recommend a full service and inspection on system prior to settlement. Forced air, Split systems, Fuel, Oil, Observation, Older unit budget for replacement. Burner, N/V, Humidifier should be replaced with a newer model.

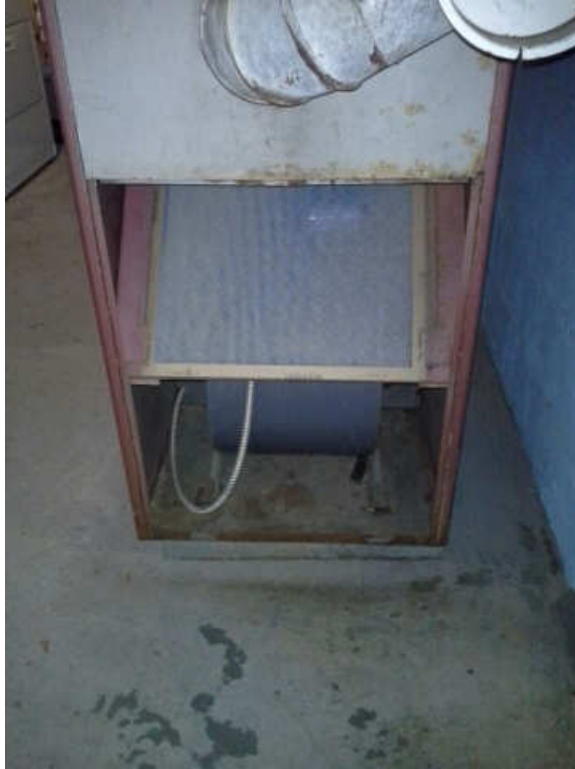
Type, Throw away type, Dirty/Missing, replace filter.

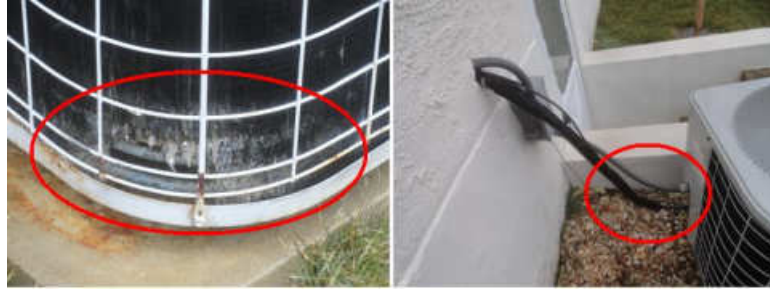
Observation, Manufacture year 1987. Unit Tons 2.5. **Coil damaged from pet urine.**
Insulation missing or failing on refrigerant Lines.

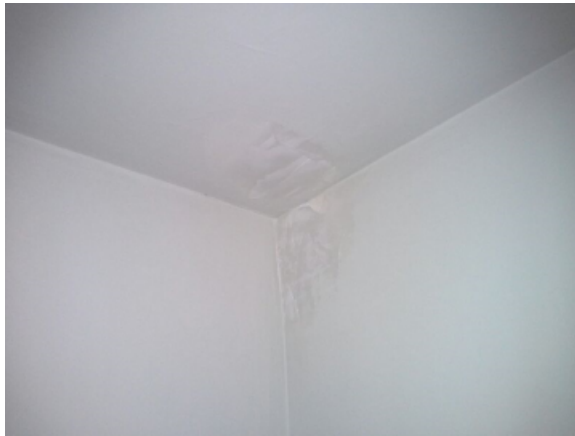
Walls observation, Drywall/Plaster. **Damage/Water stains from roof, Freshly painted.**

Ceiling observation, Drywall/Plaster. **Damage/Water stains, Freshly painted.**

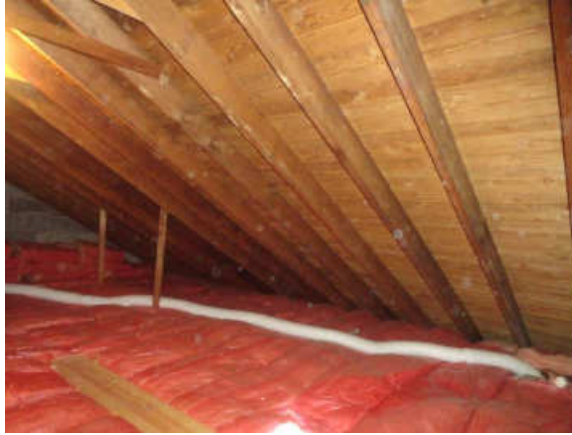
Observation, the exhaust flex pipe from the bathroom is too long.

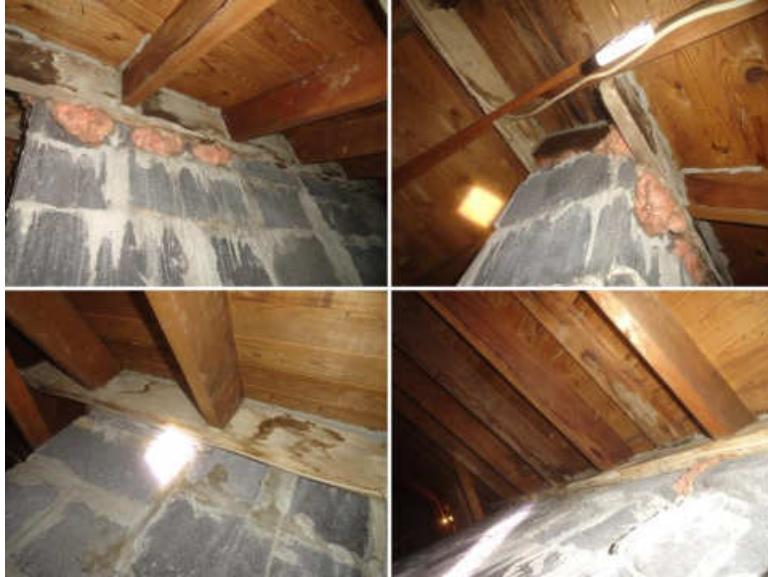
Moisture staining around the chimney.

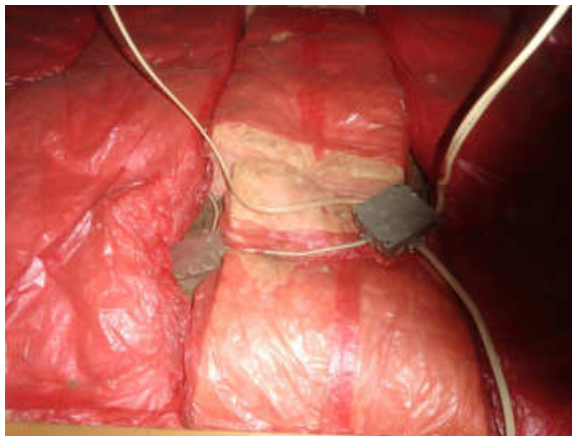
Appears adequate. **Junction boxes not secured.**

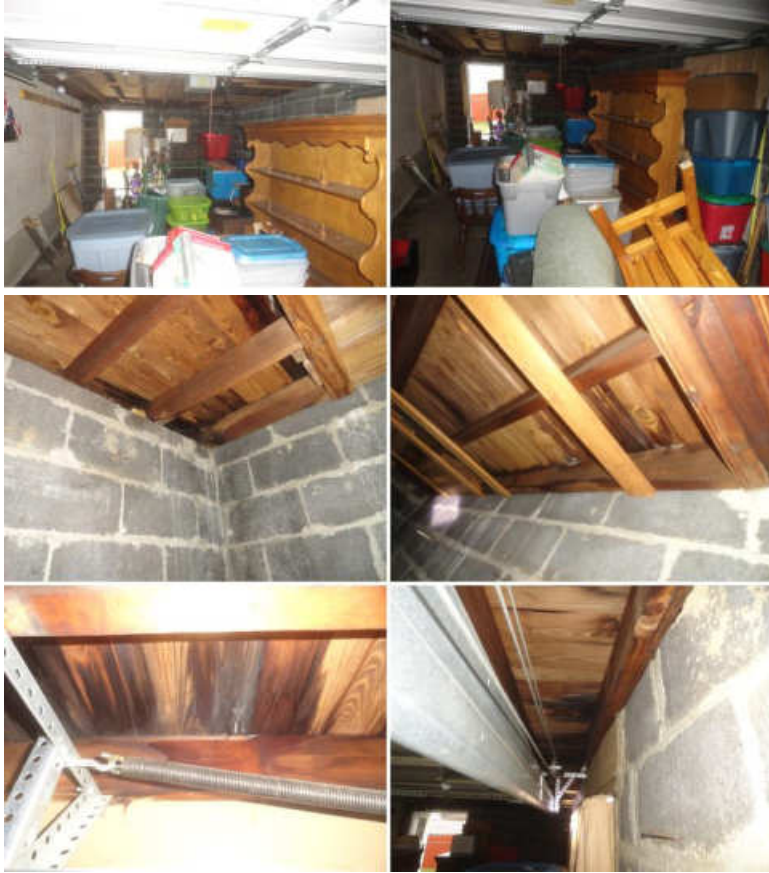
Active moisture damage inside of garage. This is coming from the garage roof.
