Inspection Summary **NOTE: Client must also review entire report and not rely solely on the summary notes.**

INSPECTION ADDRESS: West Chester, PA 19382

Confidential Inspection Report

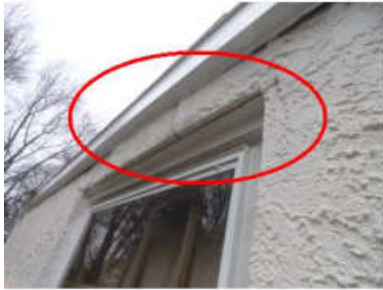
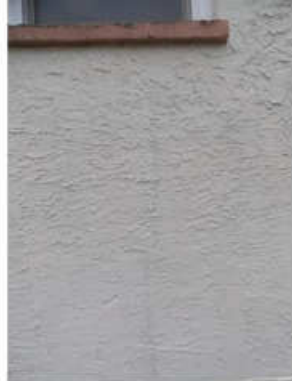
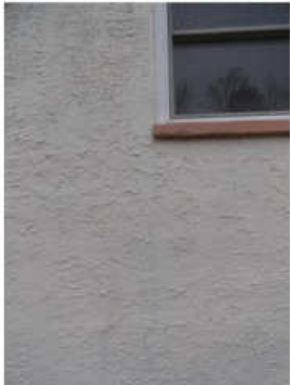
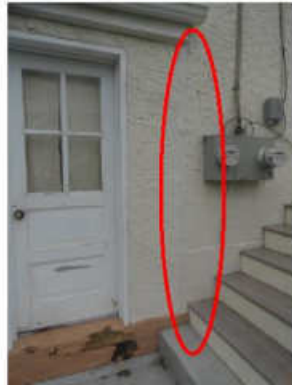
Separating, this is usually caused by water infiltration/ moisture getting behind the material. This should be further investigated and repaired prior to settlement by a professional stucco expert. There was cracking that was caulked on left side and back. The separating is happening on the garage. It is starting along the top of the wall where the roof rest on.

Previous repairs were done on cracks. **Bulge above window of garage.**

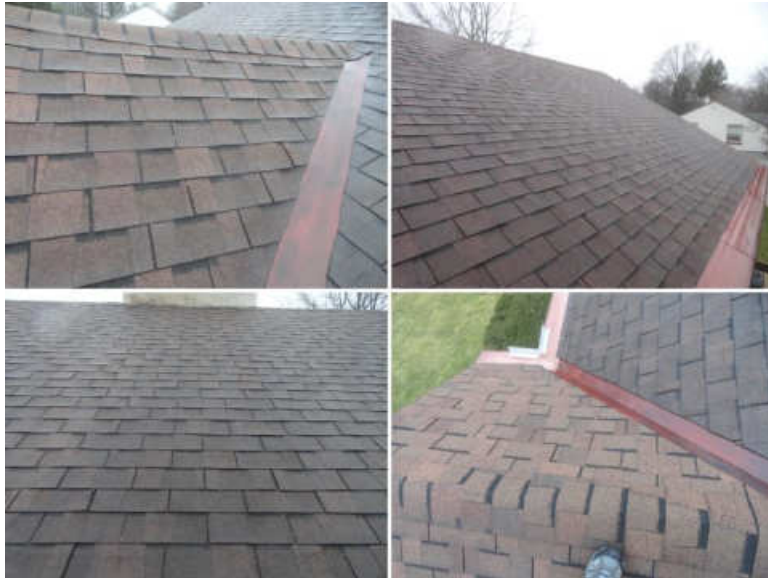
At or nearing the end of life. Roof is 15 plus years old. Cracking, heavy worn area such as holes in shingles. Recommend a professional roofer to further evaluate and repair.

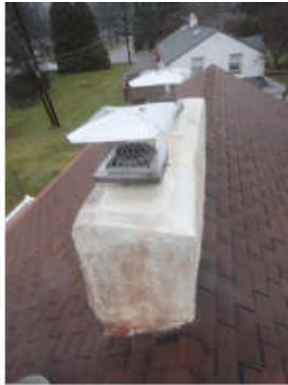
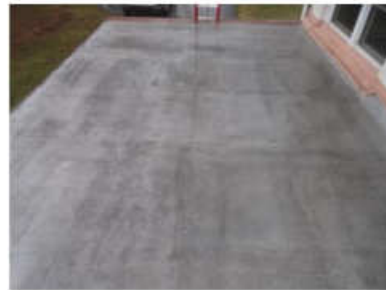
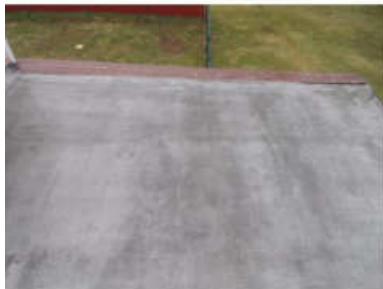
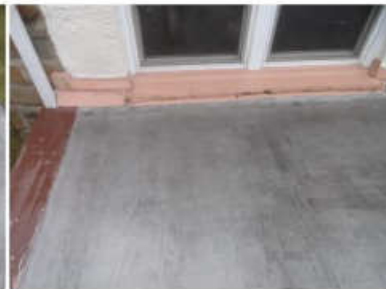
Low pitch roofs

Alligatoring, Flashing along the edges needs repairs, this is causing water infiltration behind stucco. Flashing on gutters was not installed properly, screws

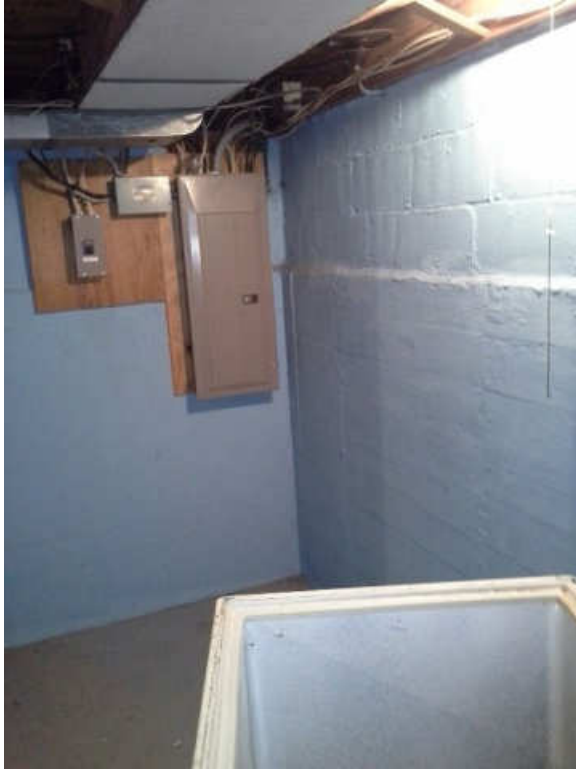
Concrete.
None visible.
None visible.
Yes.
No water to test. Receptacle should be on GFCI.
Not visible.
Appears adequate, old staining behind the powder room in basement.
Appears adequate at this time, old staining behind the powder room in basement.
Water stains.
Appears adequate at this time.

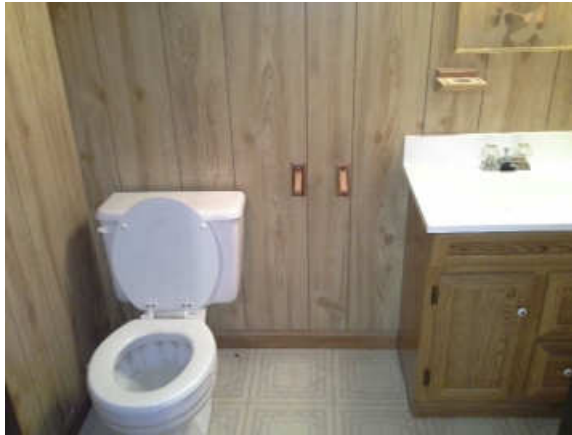
Toilets

Toilet(s), Needs new tank parts.

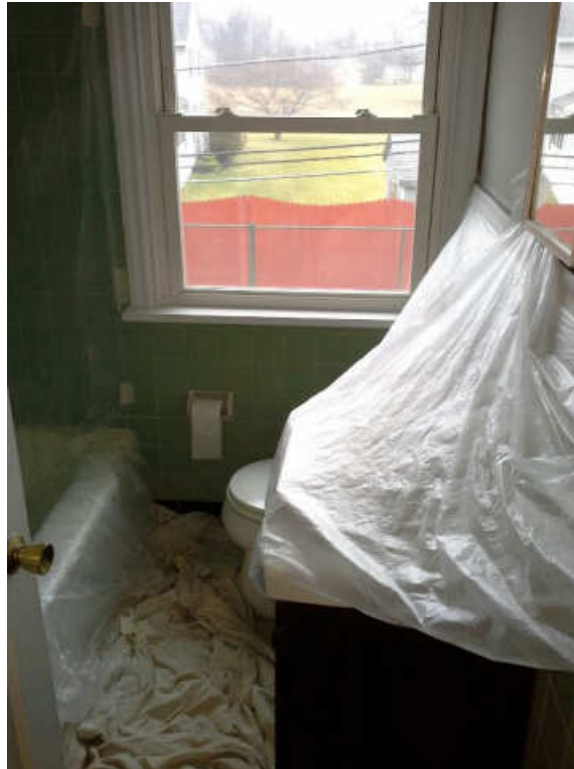
Observation, Appears functional. **Faucet, Leaks, recommend a professional plumber for repairs/replacements. Drain(s), Drain is corroded/failing, recommend a professional plumber for replacement parts.** Cabinet(s), Appears functional, Behind fixture.

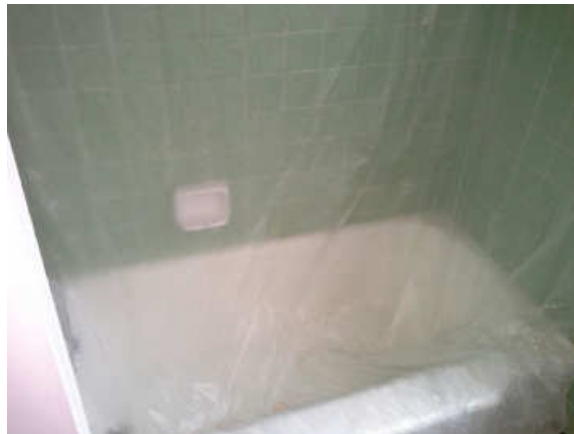
Shower

Observation, In tub, Did not check shower function because of plastic over walls.

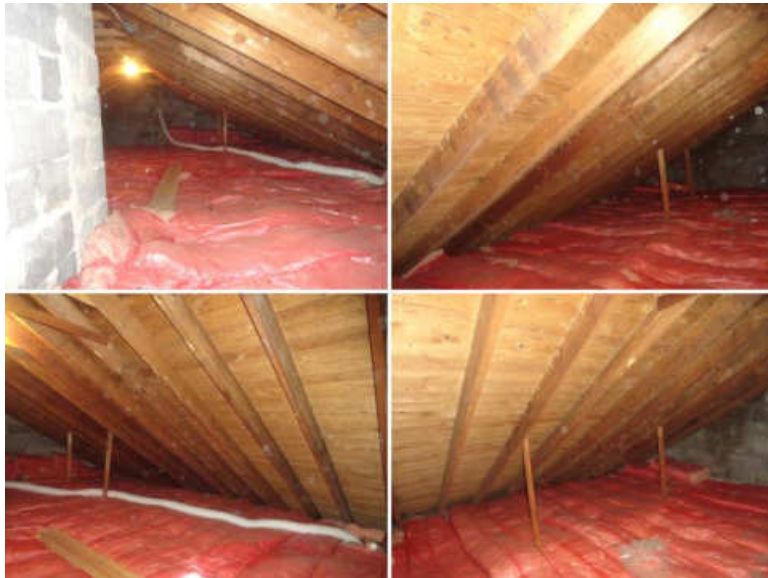
Frame

Observation

Moisture staining around the chimney.
